Inter Dyne Systems, Inc.

Report No.: 101534612GRR-001

## SPECIAL WALL MOUNTED PEG LOAD TEST:

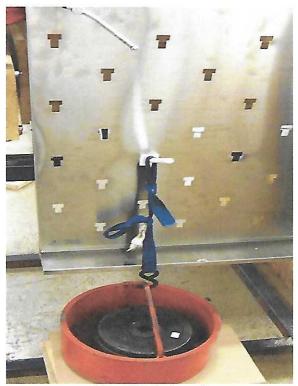
Peg Static Load

Mount the pegs to the wall per manufacturer's

instructions and load the pegs until failure

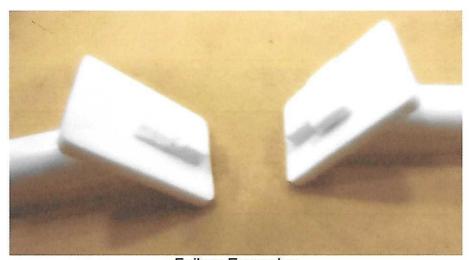
Failure Examples

Sample Number	Ultimate Static Load	Description of Results
1	160	Peg mount stripped through hole
2	160	Peg mount stripped through hole
3	160	Peg mount stripped through hole

Sample Number	155lbs Static Load	Description of Results
1	155lbs Static Load	Held the load
2 `	155lbs Static Load	Held the load
3	150lbs Static Load	Peg mount stripped through hole
4	155lbs Static Load	Held the load
5	150lbs Static Load	Peg mount stripped through hole
6	155lbs Static Load	Held the load
7	155lbs Static Load	Held the load
8	155lbs Static Load	Held the load
9	150lbs Static Load	Peg mount stripped through hole
10	155lbs Static Load	Held the load
